Hams Fork Road

Jennifer Hoffman, P.E.
Kemmerer Resident Engineer

Purpose of this meeting

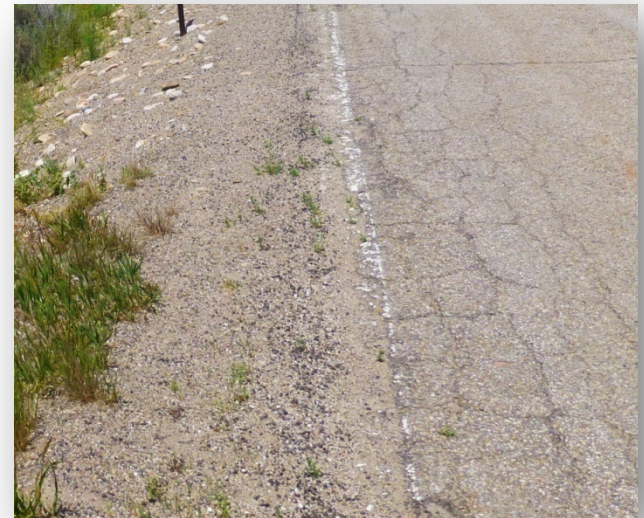
So if the chip seal was the preferred treatment, why is the road so rough and washboard-like?

- ▶ Have been investigating these possibilities:
 - Sub-grade issues (below the FDR)
 - Insufficient compaction of the FDR
 - Traffic impacts on the FDR surface before chip placement
 - Equipment impacts during construction
 - Traffic impacts on the surface after chip placement
 - Variability of the materials in the FDR (both in isolated locations and variable throughout the project)
- ▶ Any single item or combination of items may be the cause.

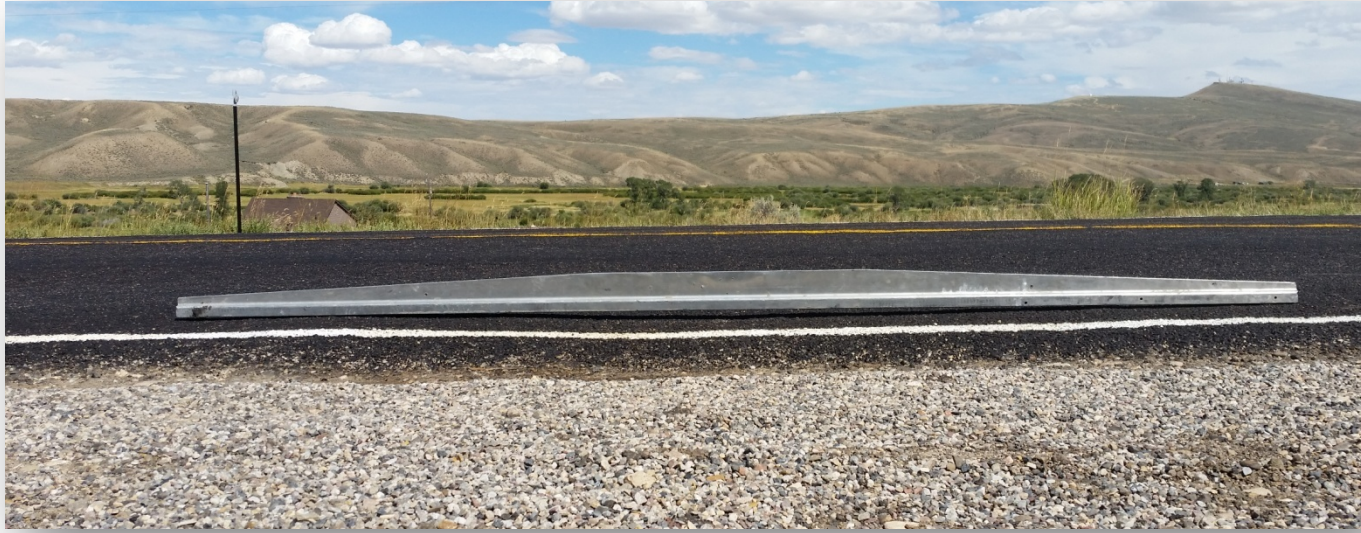
WYDOT has identified areas that do not meet ride specifications

- ▶ Some readings taken by hand

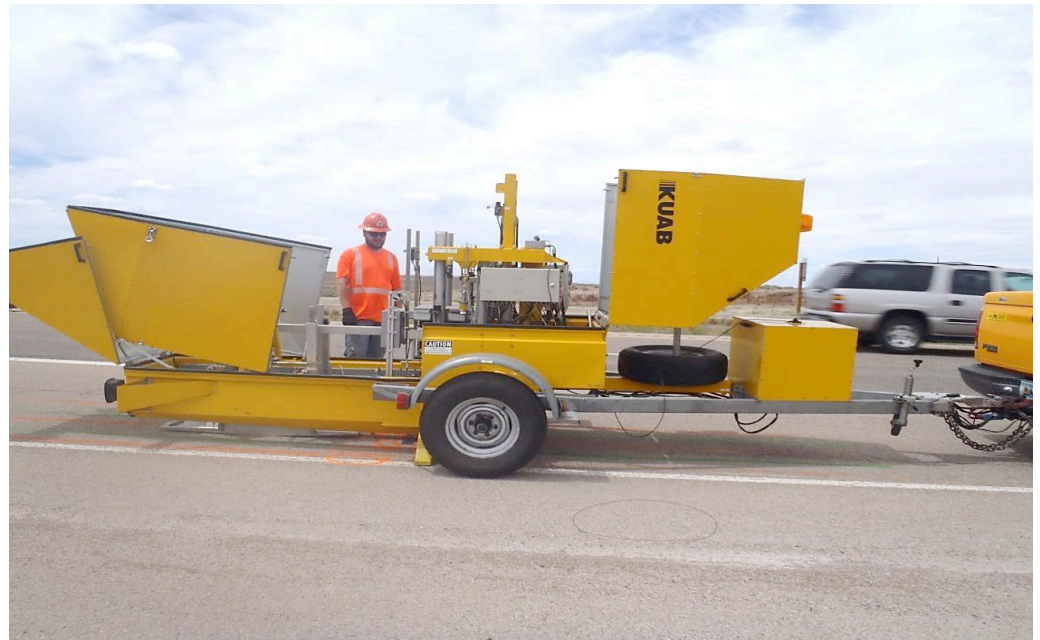
- In an effort to determine the stability of the base and sub-base a Falling Weight Deflectometer (FWD) was used to analyze the entire section at half mile intervals.
- This will be used in the discussions we're having with the contractor.

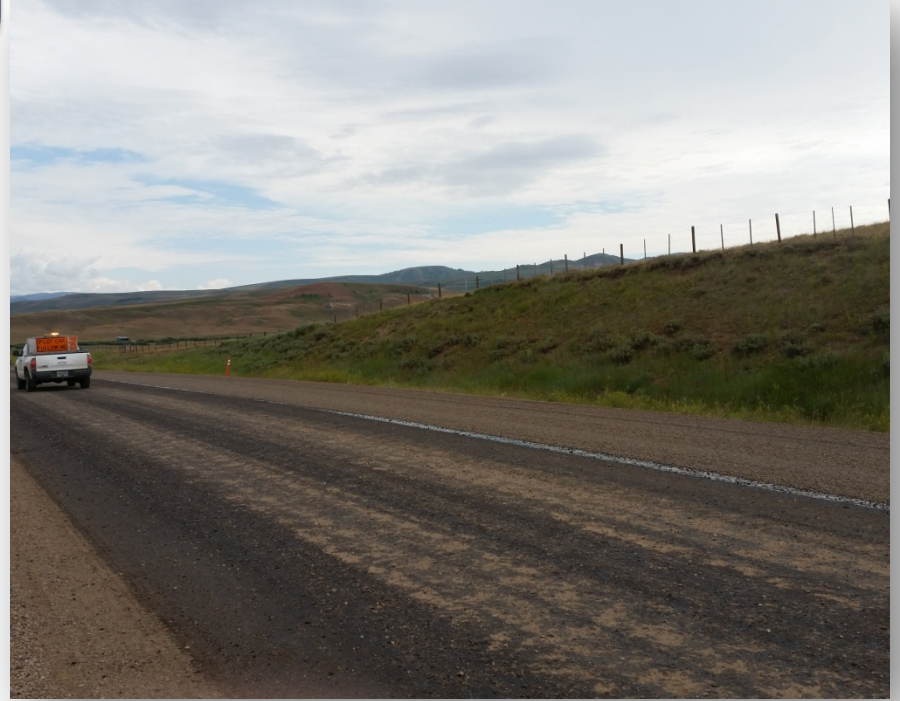
Did the road fail during construction?

- ▶ “Fog Seal” was intended for dust suppression and maintenance of the road.
- ▶ Unfortunately it started peeling off the FDR surface during the hot, sunny parts of the day. Fog seal placement was immediately stopped and some portions were removed with a motor grader.

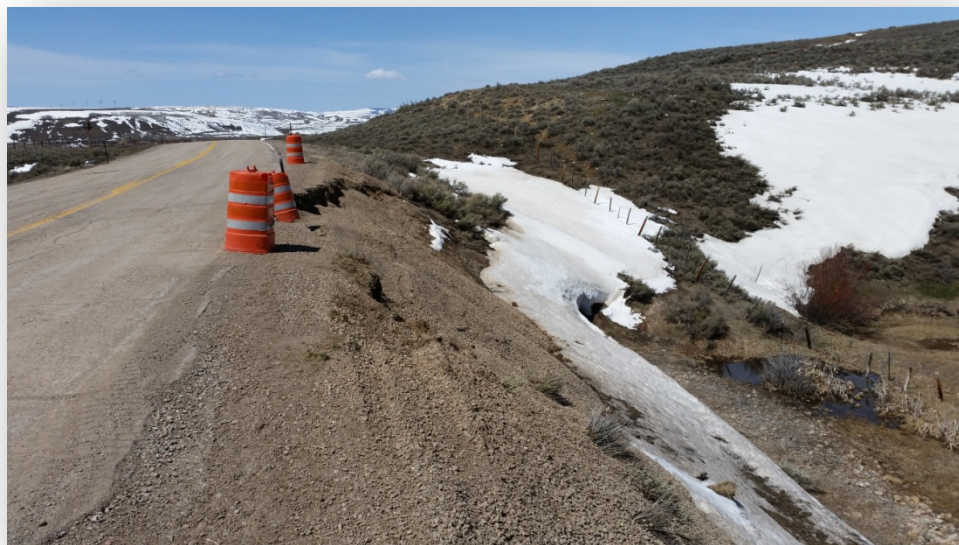
In April 2017 a slide developed at MP 10.7

Due to safety concerns, guardrail and roadway work were not performed at this location during the summer of 2017. A geotech specialty crew will be onsite within the month to begin mitigation repairs.

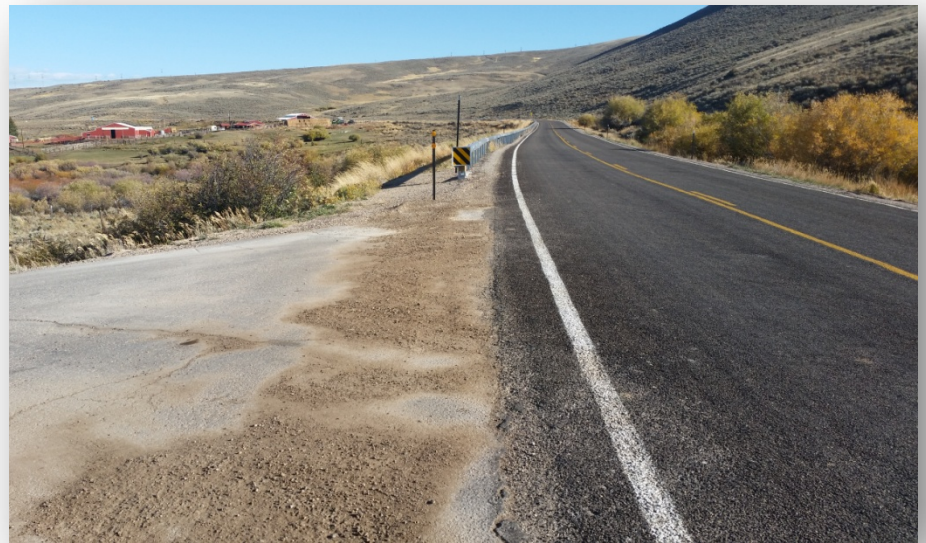
Were approaches along 233 left unlevel with drops onto driveways?

- ▶ Construction operations left behind FDR and chip seal materials along the edges of the roadway, including on approaches.
- ▶ Knife River has been working on cleaning and clearing up the shoulders and the approaches.
