FHWA-WY-10/07F

State of Wyoming
Department of Transportation

BRIDGE DECK EVALUATION USING NONDESTRUCTIVE TEST METHODS

March 2012

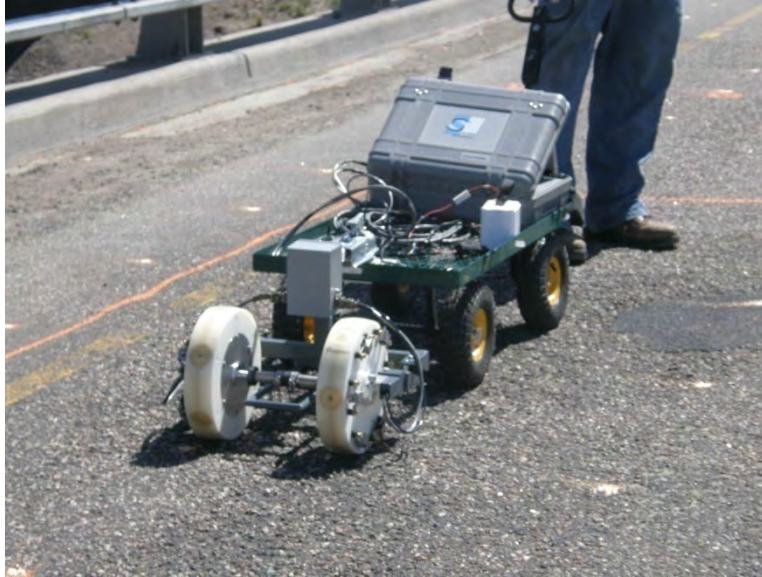
Olson Engineering is developing a vehicle-mounted scanner consisting of a set of wheels with six impact echo devices spread around the perimeter to increase the speed of data acquisition. Figure 5 shows a prototype of the scanner (Tinkey and Olson 2010).

Figure 5: Olson Engineering's Impact Echo Bridge Scanner.

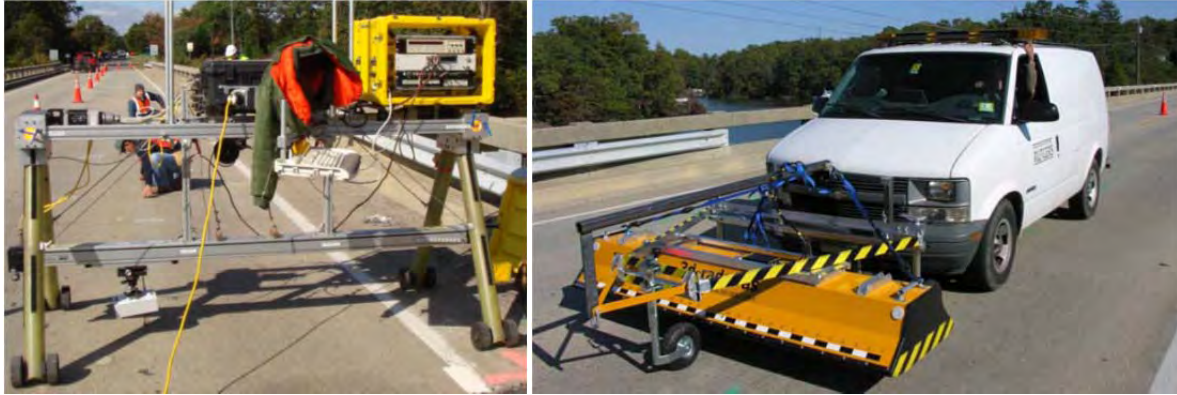
Figure 9: PERES II system and vehicle mounted systems (Huston et al. 2007b).

Air-coupled systems were used in vehicle mounted systems as early as 1992 (Alongi et al. 1993). Two air-coupled systems were developed by the Lawrence Livermore National Laboratory for the Federal Highway Administration (FHWA) (Warhus et al. 1994). High-speed Electromagnetic Roadway Mapping and Evaluation System (HERMES) was designed to survey deck condition during normal traffic flow. Precision Electromagnetic Roadway Evaluation System (PERES) is slower and provides a more accurate survey (Davidson and Chase 1998; Scott et al. 2000). FHWA funded the PERES system, a second generation of the HERMES (Huston et al. 2007a, b). It is much simpler and uses one antenna, whereas the HERMES system uses 64 antennae to get a wider scan in a single pass (Scott et al. 2000). The PERES system consists of an air horn antenna mounted onto two A-frames moved manually along the road (Huston et al. 2007a, b). Images of the van-mounted system and the PERES system are shown in Figure 9. The air horn systems must be calibrated for the distance from the bridge deck to the antenna.

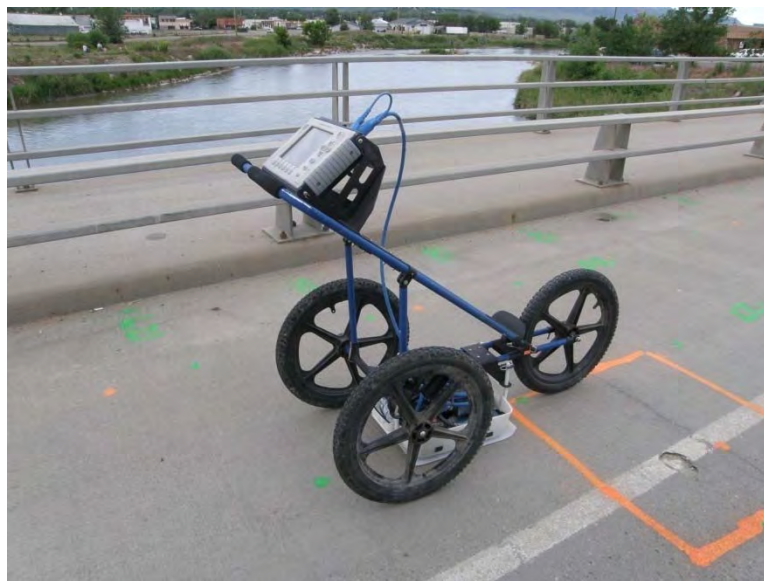
Figure 10: Typical GPR ground-coupled cart.

Ground-coupled systems rest directly on the roadway surface and transmit the impulses and return data in a form similar to that of the air-coupled system. Geophysical Survey Systems, Inc., (GSSI) developed and sells a self-contained, cart-based GPR system, which claims to accurately estimate repair costs (Figure 10). An optional GPS system can be integrated into the GPR in to ease data interpretation.

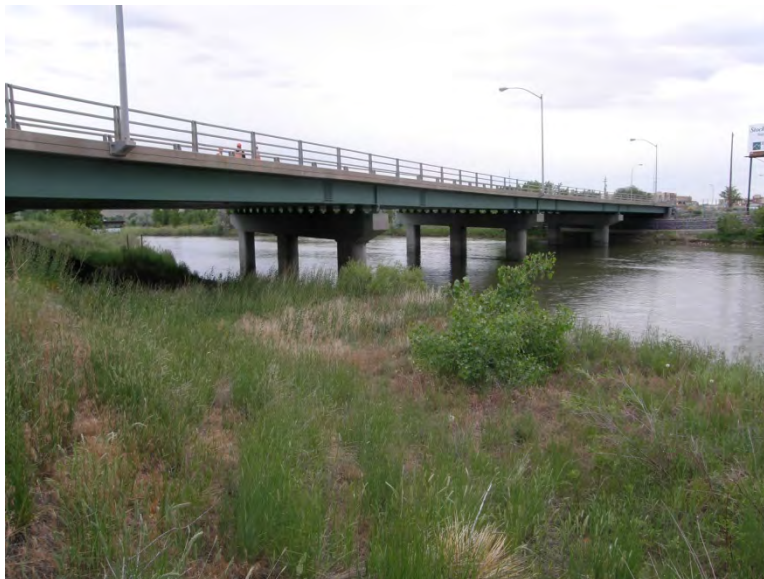
Figure 11: First Street Bridge in Casper, Wyoming.

The first bridge, with a bare concrete deck, is located on First Street in Casper, Wyoming, at milepost 2.09. The bridge contains 4 spans over the North Platte River, and the deck was designed to be 7 in. deep. The centerline length is 360 ft with skewed ends and a radius of 955 ft. The tests were conducted during the week of June 15, 2009. Only the eastbound lanes were evaluated due to weather and time constraints. Figure 11 shows the bridge looking northeast. Figure 12 shows the underside construction of the bridge.

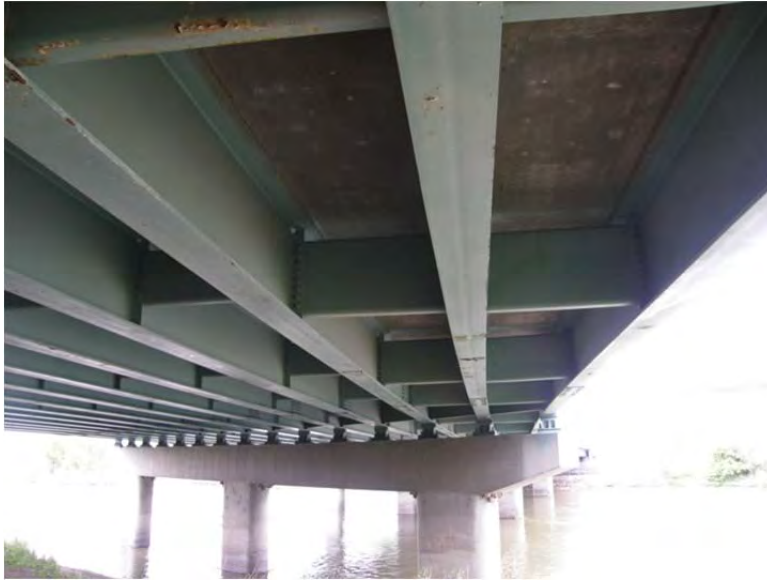
Figure 12: First Street Bridge underside in Casper, Wyoming.

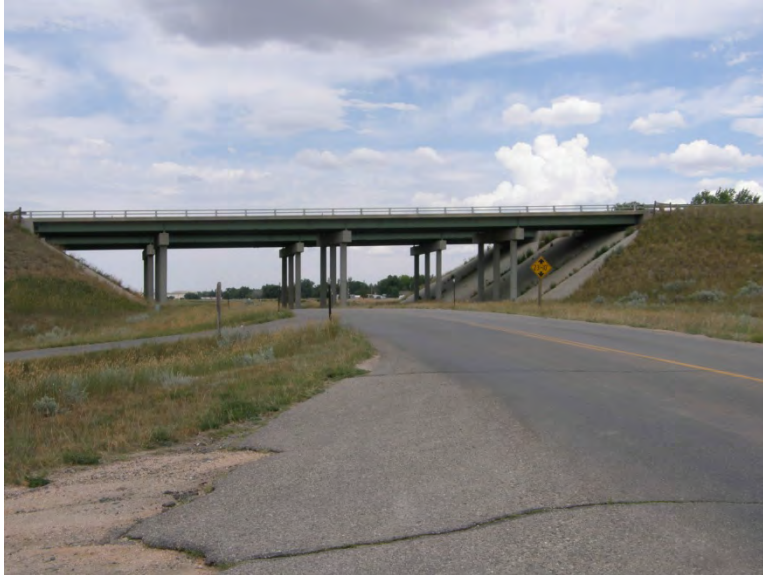
Figure 13: Southbound I-25 (Structure AFY) Bridge in Douglas, Wyoming.

The second bridge, which had a latex modified concrete overlaid deck, is located in Douglas, Wyoming on the southbound lanes of I-25 (structure AFY) at milepost 137.6. The bridge is 186' long with skewed ends and contains four spans. The deck was designed to be 7.25 in. deep; the overlay increased the depth to 8 in.

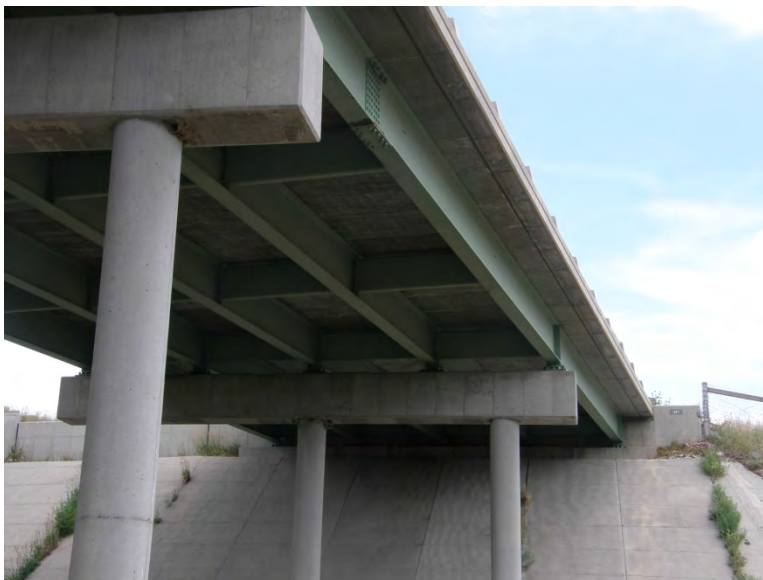
Figure 14: Southbound I-25 (Structure AFY) Bridge underside in Douglas, Wyoming.

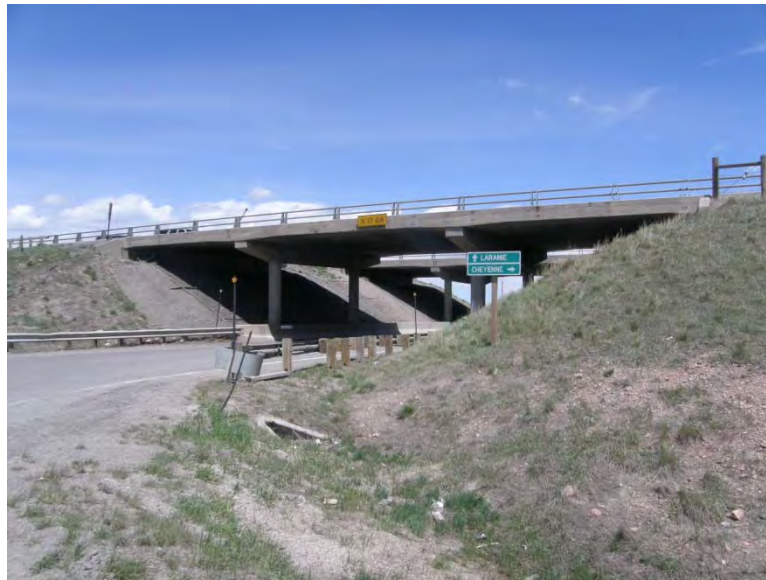
Figure 15: Eastbound Remount Bridge (structure AYB), near Buford, Wyoming.

The third bridge, the eastbound bridge of the Remount Interchange on I-80 (structure AYB), recently had an asphalt overlay applied after a traffic accident occurred. A silica fume overlay was present and partially milled off before the asphalt overlay was applied. Located at milepost 339.32, this bridge is three spans and is 93 ft long. Initial tests with the asphalt overlay

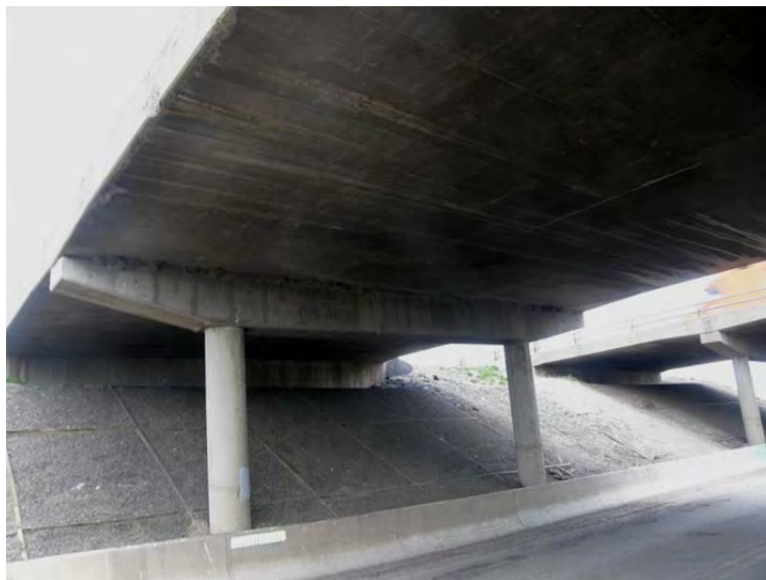
Figure 16: Eastbound Remount Bridge (structure AYB) underside, near Buford, Wyoming.

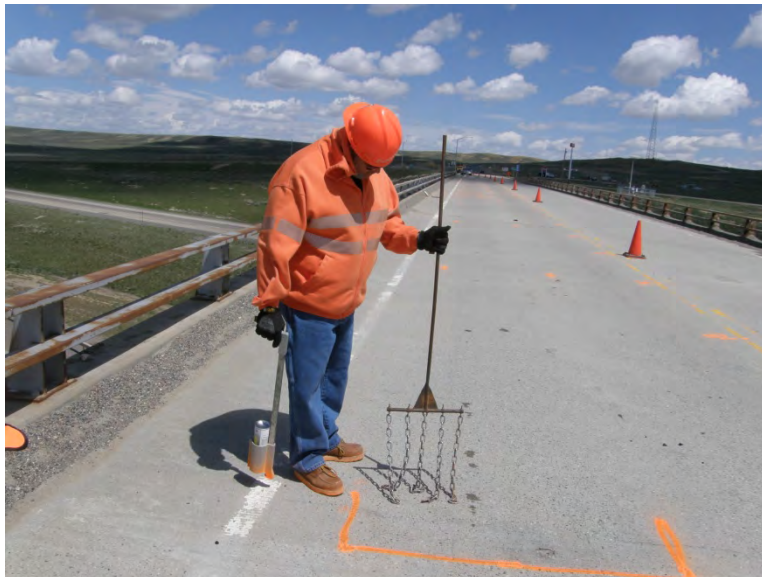
WYDOT performed all chain dragging and half-cell potential evaluations on all three bridges. Chain dragging evaluations were set up on a 5 ft by 5 ft grid to help with documentation. The entire deck is then dragged by the evaluator. Whenever a dull or hollow sound was heard, the area was outlined for documentation at the end of the test. Figure 17 shows a WYDOT inspector conducting a chain drag test.

Figure 17: Chain dragging evaluation.

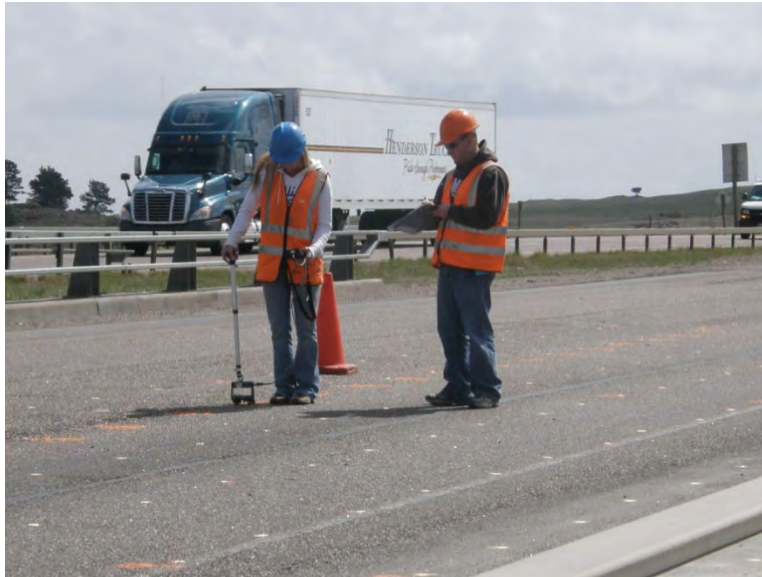
Figure 18: University of Wyoming researchers performing impact echo test.

To gather data for the impact echo test, a digital sounding device was used to measure the depth of concrete decks (Olson Instruments Concrete Thickness Gauge CTG™). This device uses a solenoid that strikes the surface and a receiver that converts the reading to concrete depth via a Fast Fourier Transform. Figure 18 shows impact echo tests being carried out by the University of Wyoming researchers.

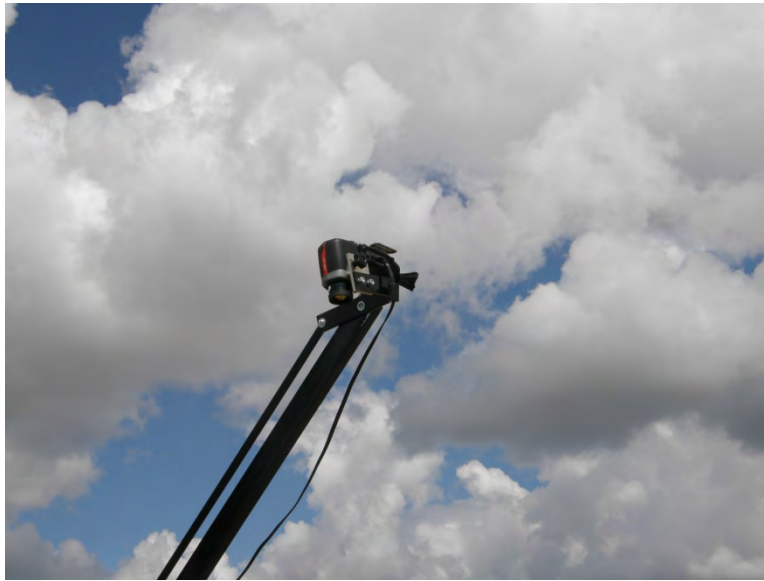
Figure 19: Thermal camera.

accuracy of ± 3.6 °F. It should be noted that this level of accuracy was reduced due to lens that was used to increase the area the camera could cover in one photograph. The camera used for the Remount Bridge, with and without the overlay, and the Douglas Bridge, without the overlay, was a FLIR B200, which has the same resolution and accuracy as the T250, but with a narrower range of readable temperatures. A boom and cart were used to raise the camera and orient it perpendicular to the bridge deck surfaces. Figure 19 and Figure 20 show the camera and the setup that was used.

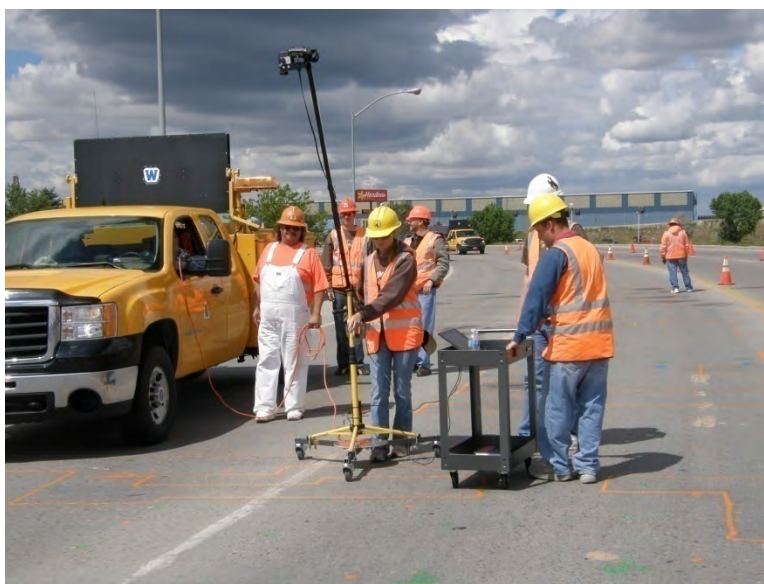
Figure 20: Thermal camera setup.

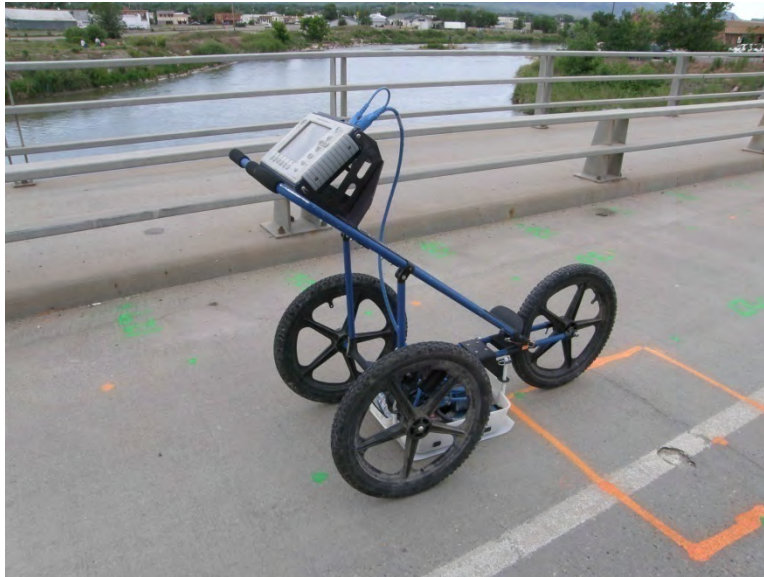
a thorough evaluation. The ground-coupled system (Figure 22) was mounted on a cart similar to a jogging stroller. The antenna can also be used without a cart (Figure 23). The truck-mounted system (Figure 24) was used on a pickup truck. Both systems used a GSSI interface (Figure 25).

Figure 22: Ground-coupled GPR system.

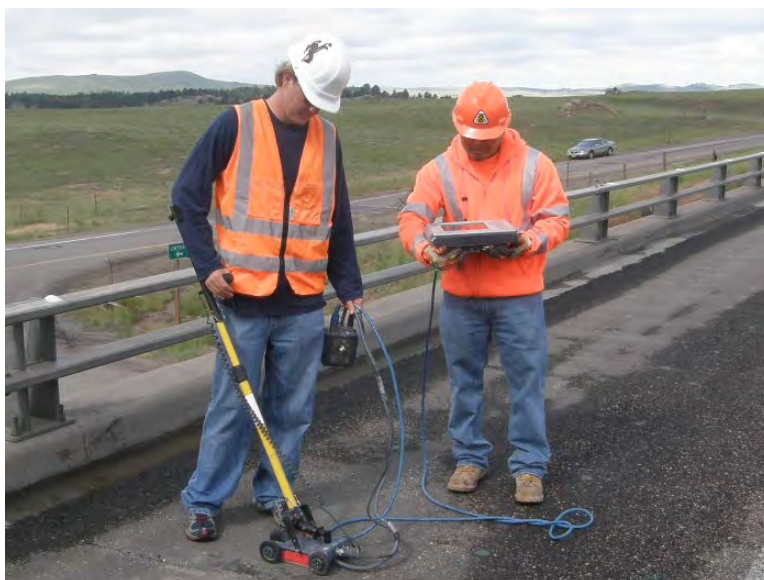
Figure 23: Ground-couple GPR system without cart.

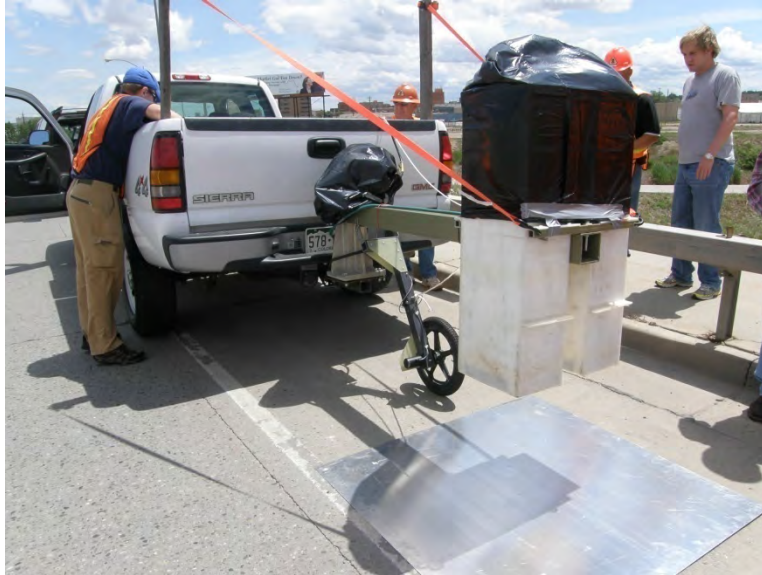
Figure 24: Truck-mounted GPR system.

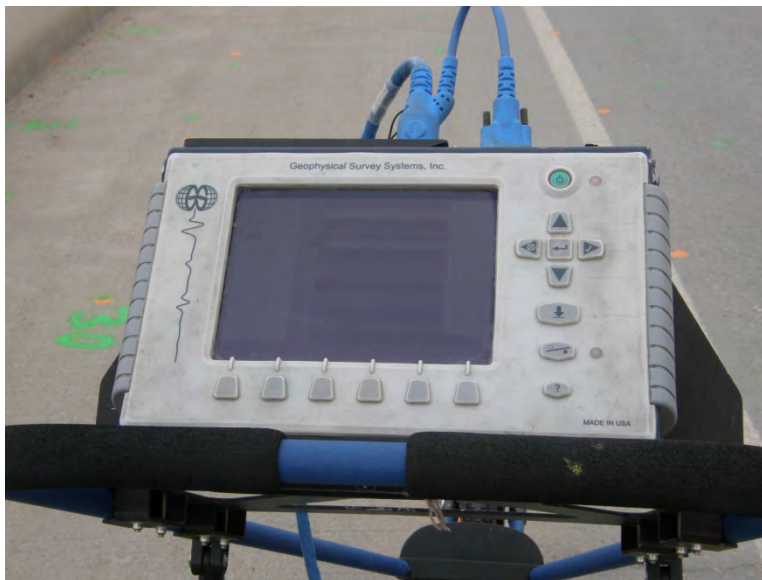
Figure 25: GSSI interface that Olson Engineering uses.

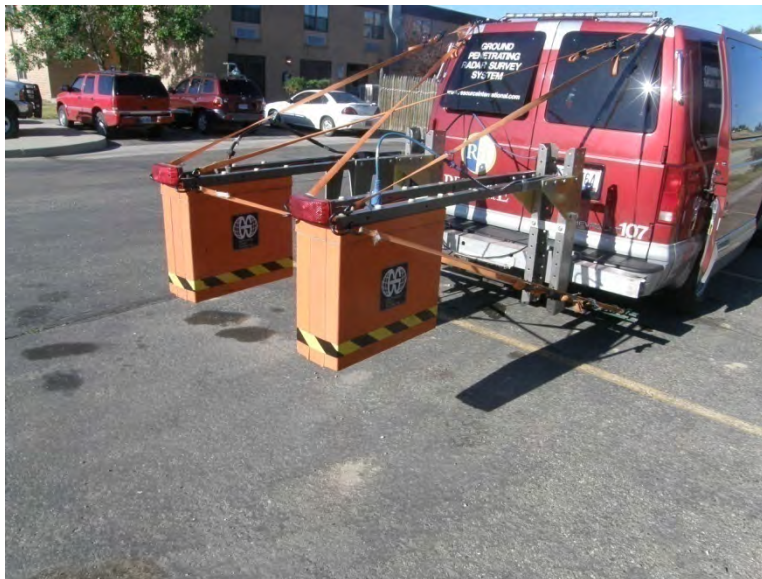
Figure 26: Radar apparatus on Rii's van.

Another GPR air-coupled test was performed by Resource International, Inc. (Rii) from Ohio for comparison purposes. This system was able to travel at 30 mi/h without impeding traffic. Figure 26 shows the vehicle mounted GPR setup on the Rii van. Douglas Bridge with the overlay was evaluated in this subcontract.

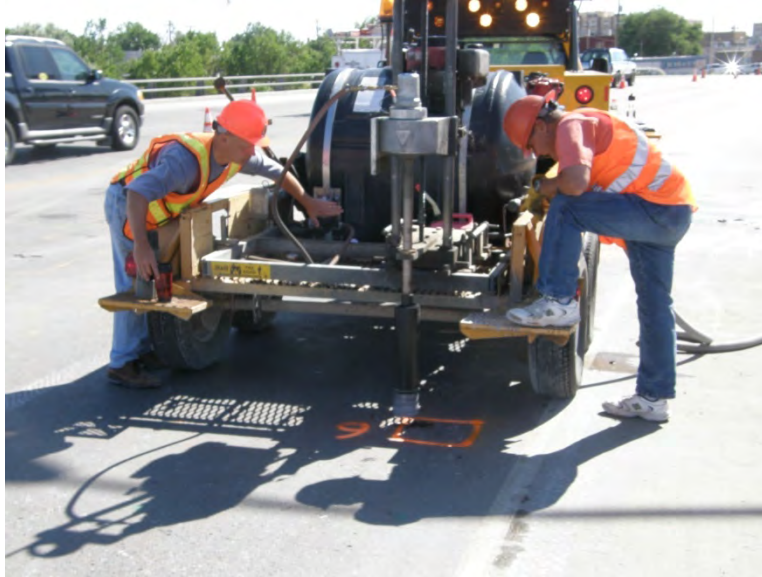
Figure 28: Coring rig on Casper Bridge.

Cores were removed from each bridge to give a visual confirmation of the damage to the bridge deck in locations that had a range of methods indicating areas of concern. Areas that did not indicate damage were also taken to give a control core to compare with the others when possible. The overlay was present when the cores from the Douglas Bridge were removed whereas the coring on Casper and Remount bridges occurred on the bare concrete decks. The individual tests conducted on the cores are discussed in Appendix A for each of the bridges. Figure 28 shows the coring rig removing a core on the Casper Bridge. Although different crews were utilized to remove cores on each bridge, Tyler Robison was present for all coring.

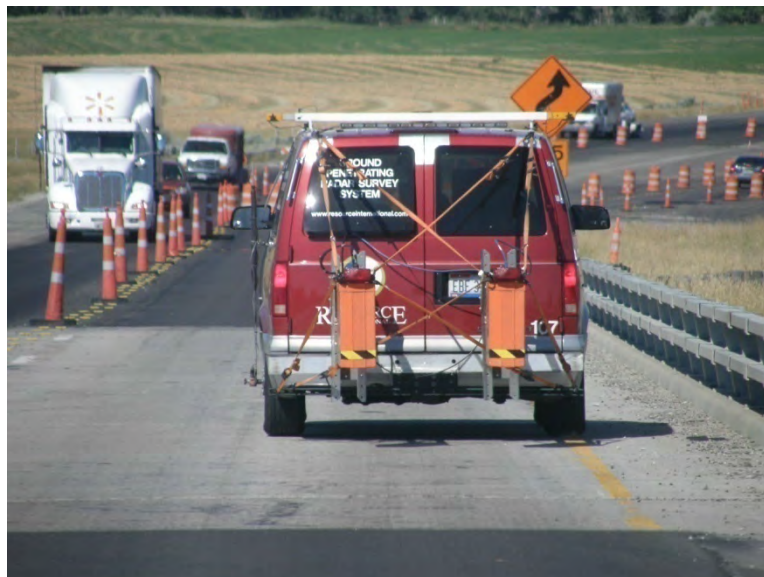
The Douglas Bridge also utilized Rii's van-mounted system when the overlay was present. The test was conducted at 30 mph with scans taken every 1.5 ft transversely. Multiple passes were made to obtain accurate data. A WYDOT truck provided support by slowing traffic down behind the van with an arrow board. The antennas, from GSSI, were 1000 MHz. Figure 29 shows the van-mounted system in the field.

Figure 29: Rii's van-mounted system scanning the bridge.

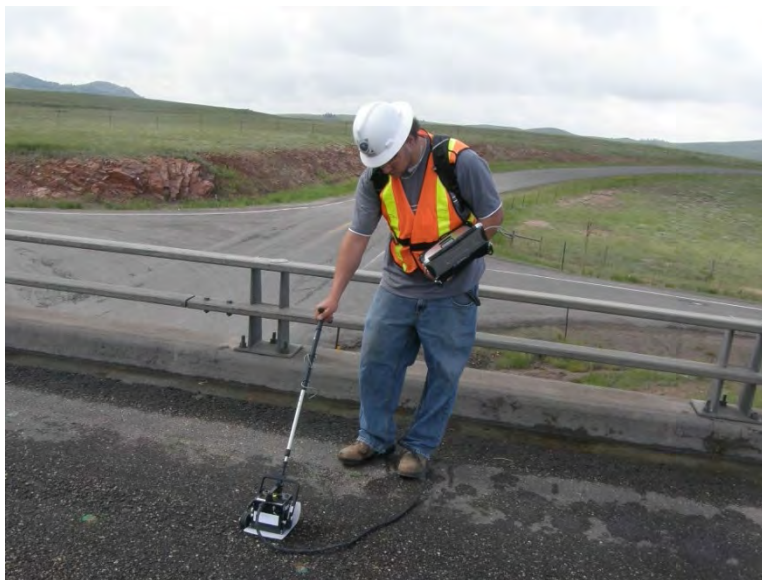
Figure 30: IDS Aladdin ground-coupled radar system.

The new GPR system from IDS was also used on the Remount Bridge (Figure 30). This system was moved across the transverse direction at 10 cm intervals. Carts were not utilized due to the short distances and the possibility of the cart sticking out into traffic.

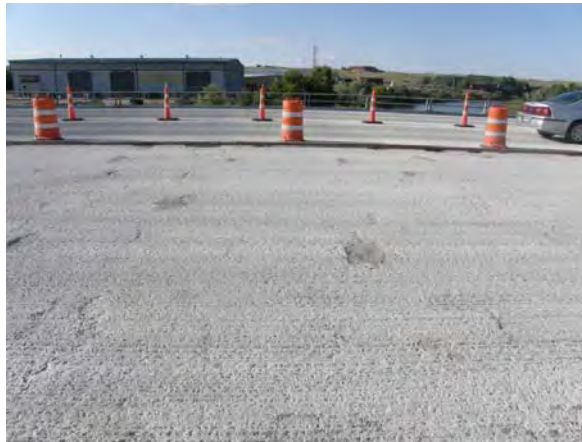
The Casper Deck was milled for repairs, which revealed some areas of delamination. A visual inspection of the milled deck showed the most damaged area was from 142 ft to 180 ft (Figure 35 and Figure 36). This confirms the analysis from the other methods, as they also indicate large areas of damage in this zone. Differences in depths of damage could not be determined by these tests.

Figure 35: Casper Bridge milled surface (140 ft to 160 ft).

Repairs were classified into four categories: Class I-A (1/4 in. removal depth), Class I-B (2 in. removal depth), Class II-A (4 in. removal depth, typically half the thickness of the deck), and Class II-B (full depth removal). Actual repairs consisted of Class II-A over 18% of the bridge deck as shown in Table 12. The NDE methods predicted between 11 and 17% damage (Table 13) which correlates well with the actual repairs.

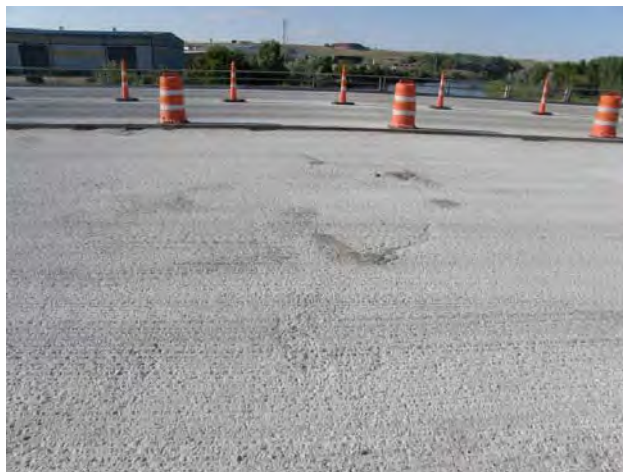
Figure 36: Casper Bridge milled surface (160 ft to 180 ft).

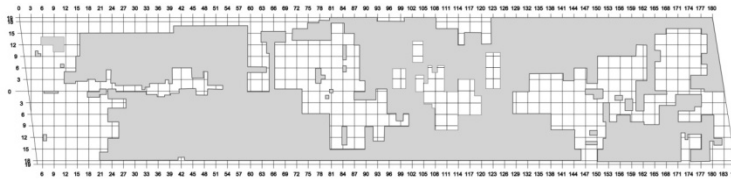
Chain Dragging

Chain dragging, impact echo, and thermal imaging results were compared (Figure 38). Useful GPR results were not available on the milled concrete surface due to direct coupling interference from the reflections from the top surface of the bridge deck and the signal from the reinforcing bars. This distortion made the reinforcing steel appear more corroded than during the evaluation including the overlay (Olson Report 3016B in Appendix B). This leads to overzealous estimations of damaged and corroded areas. Section 5.2.4 provides a direct comparison of sample scans showing the increased response of the steel from the deck with the overlay removed.

Figure 38: Comparison of delamination results of Douglas Bridge without overlay.

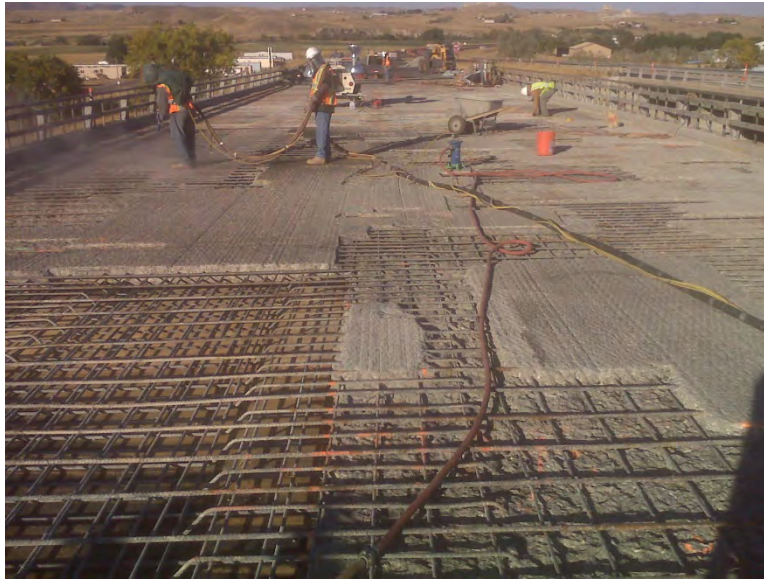
Figure 44: Douglas Bridge chipping looking east.

This section presents the actual repairs that were made to the Douglas Bridge. Every portion of this deck required milling and chipping. Figure 44 and Figure 45 show the extent of the necessary repairs.

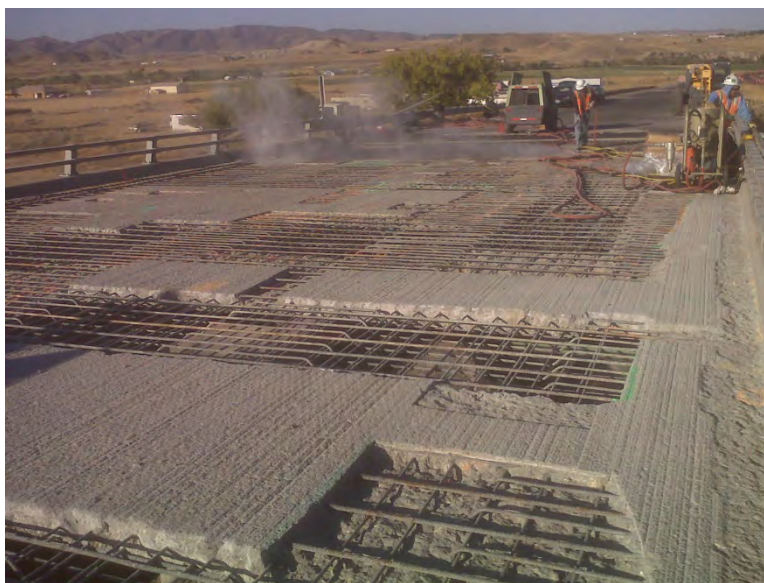
Figure 45: Douglas Bridge chipping looking east.

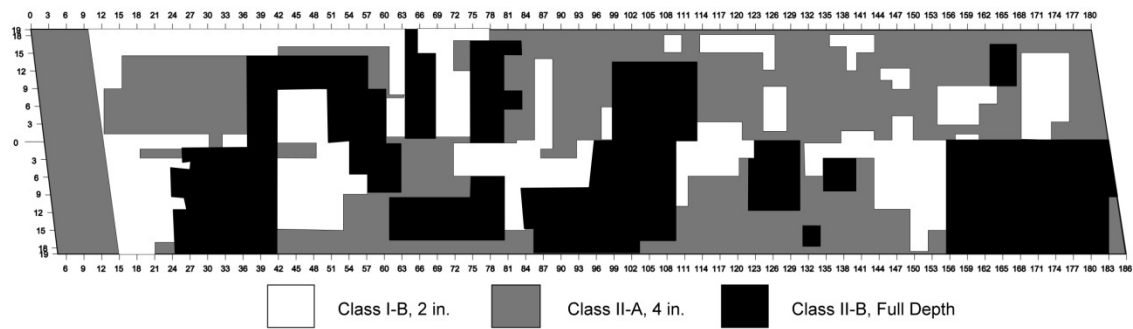
A comparison of the repair schedule was made to the half-cell potential results of the Douglas Bridge when the overlay was present (Figure 47). When the voltage potential was larger, a deeper repair was needed. The purple-filled areas represent the areas that have the largest voltage reading.

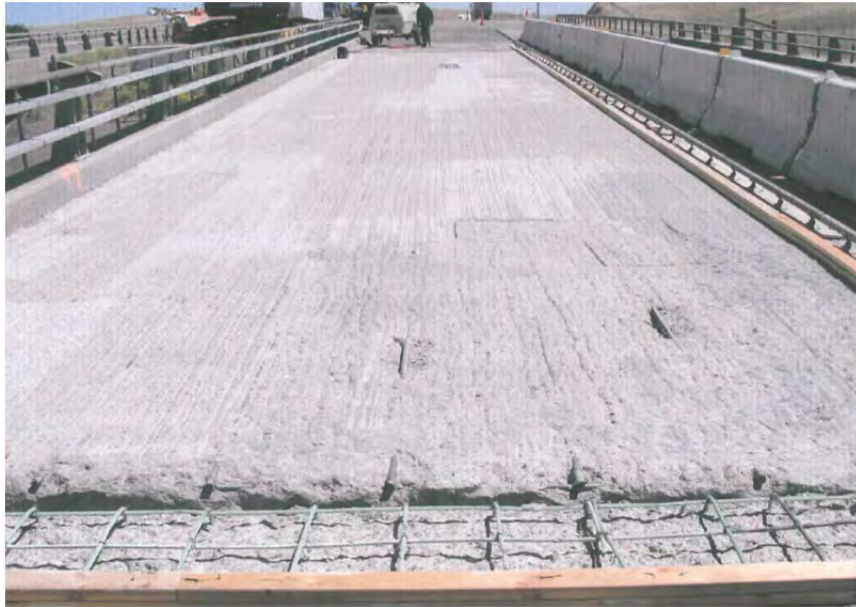
Figure 54: Remount Bridge reconstruction.

- Reinforcing steel was coated which caused problems with the corrosion data collection and analysis using the half-cell potential method.
- Longitudinal reinforcing steel was placed above the transverse steel. This resulted in running the GPR system in the transverse direction rather than along the length of the bridge.

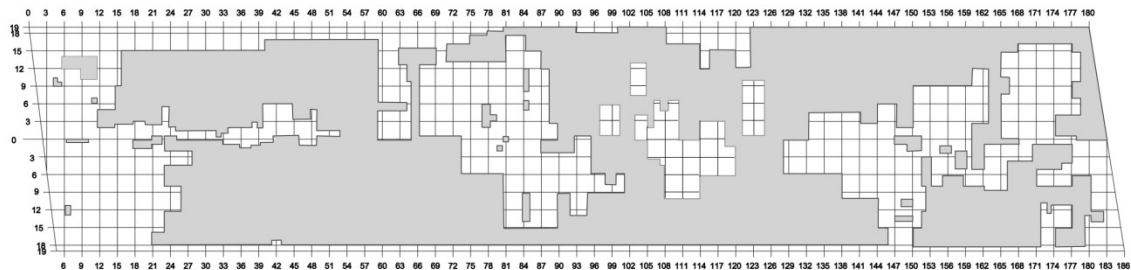
This section presents the results of the chain drag and half cell potential tests, which were performed by the WYDOT bridge crew. Figure A.24 shows the detected damage and delaminations from the chain dragging test, which indicated that 58% of the deck was delaminated. Figure A.25 shows the half-cell equipotential contour map. The purple-filled regions represent areas of -0.35 V or more negative, where there is a greater than 90% probability of corrosion according to ASTM C 876. The purple outlined area represents a potential -0.2 V to -0.35 V. The results, provided by WYDOT, have been overlaid on the grid to standardize all of the tests for comparison. Table A.16 displays the percent potential corrosion corresponding to voltage increments from the results.

Figure A.24: Chain drag results outlining areas of delaminations

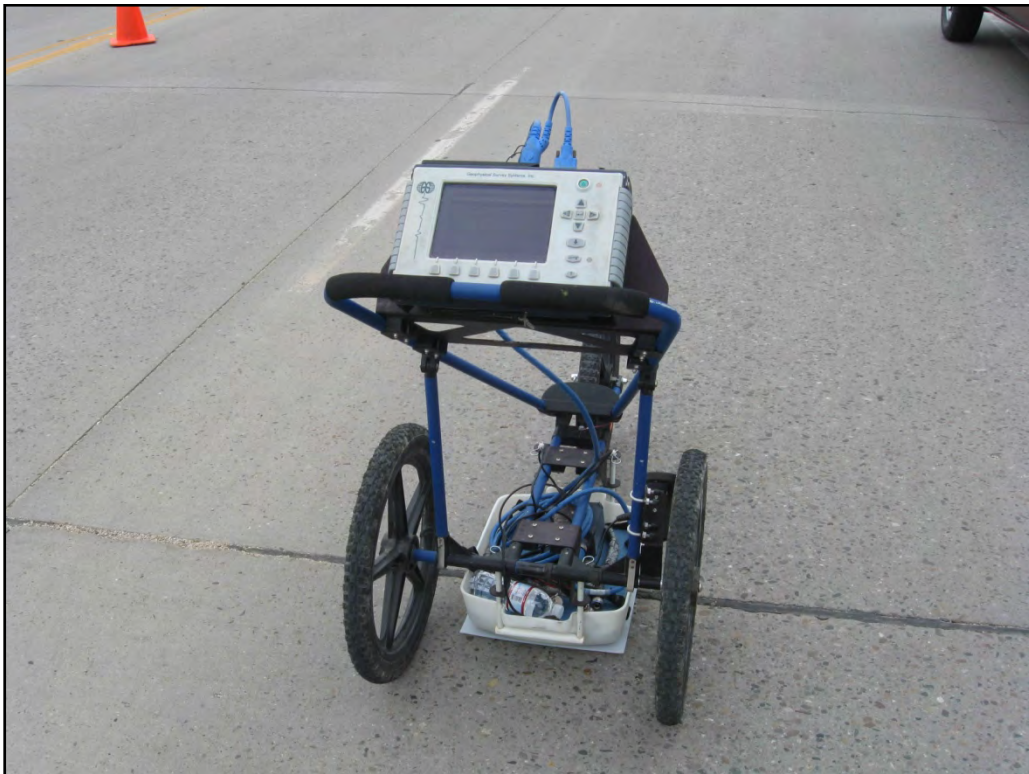
Figure 2 - SIR-3000 GPR system with a 1500MHz ground coupled antenna mounted on a cart.

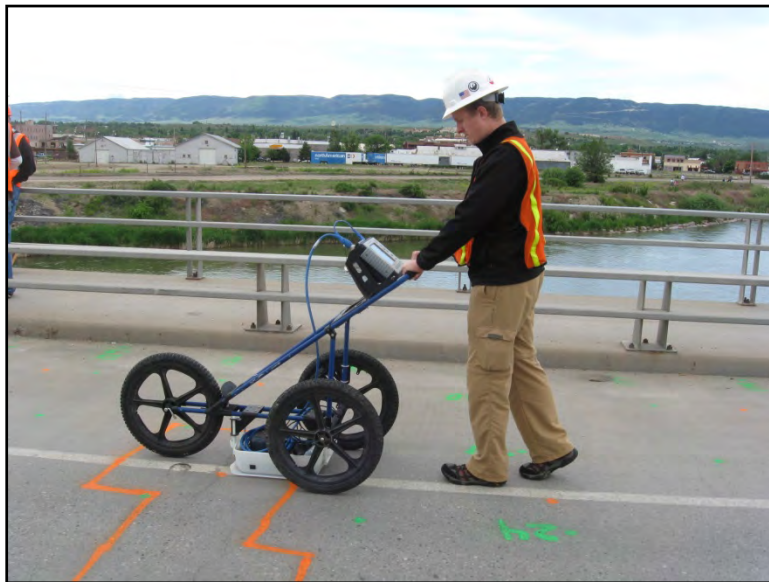
The GPR tests were performed using a Geophysical Survey Systems, Inc., 1500 MHz ground coupled antenna as well as a 1 GHz (1000MHz) air horn antenna along the length of the concrete bridge deck. The tests were performed on the top of the deck (Figure 3) per drawings provided by the Wyoming Department of Transportation (WYDOT). Traffic control for the testing was also provided by WYDOT. The deck was scanned with the 1500 MHz antenna using a grid spacing of 1.5 feet along the N-S direction (width of the bridge) and 0.25 inch along the W-E direction (along a scan line). GPR data files were recorded in the eastbound direction, in one and a half foot transverse intervals from the centerline of the bridge to the south curb edge. The 1 GHz air horn antenna data was collected from 4.5 feet inside the centerline to 4.5 feet from the curb due to limitations based on the width of the truck the radar antenna was mounted on. The objective of the GPR tests was to determine areas of the bridge deck with potential corrosion or delamination (cracks) at the top layer of steel reinforcement.

Figure 3 - GPR testing with the 1500MHz ground-coupled antenna over the North Platte River in Casper, Wyoming.

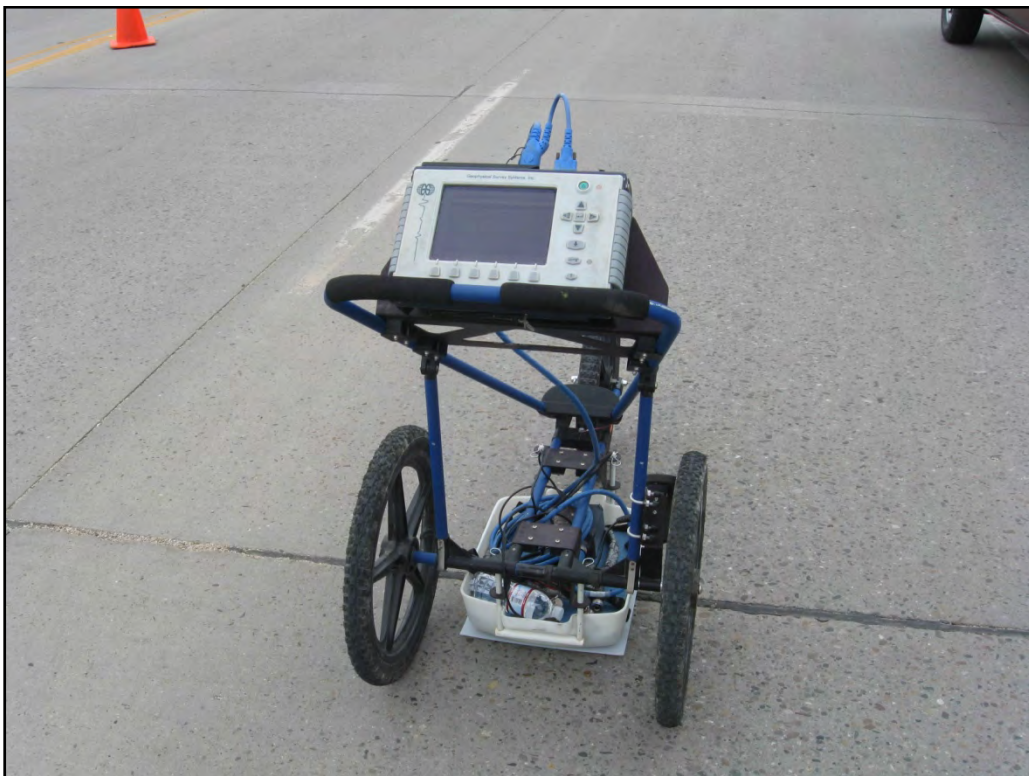
Figure 2 - SIR-3000 GPR system with a 1500MHz ground coupled antenna mounted on a cart.

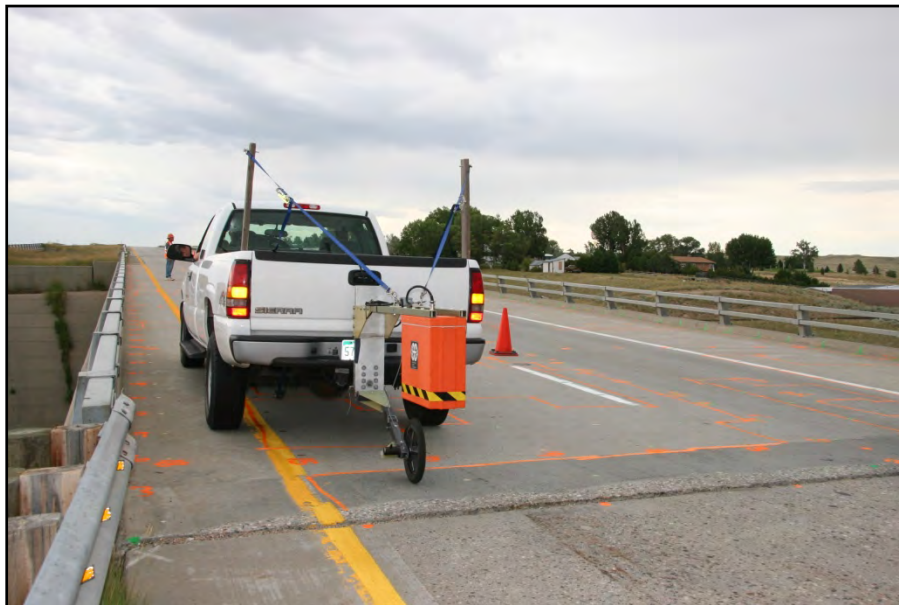
The GPR tests were performed using a Geophysical Survey Systems, Inc., 1500 MHz ground coupled antenna as well as a 2 GHz (2000 MHz) air horn antenna along the length of the concrete bridge deck. The tests were performed on the top of the deck (Figure 3) per drawings provided by the Wyoming Department of Transportation (WYDOT). Traffic control for the testing was also provided by WYDOT. The test area was scanned using a grid spacing of 1.5 feet along the N-S direction (width of the bridge) and 0.25 inch along the W-E direction (along each scan line). GPR data files were recorded in the westbound direction (in the eastbound lanes), in one and a half foot transverse intervals from the south curb edge of the bridge to the north curb edge. The 2 GHz air horn antenna collected from 4.5 feet inside the centerline to 4.5 feet from the curb due to the width of the truck the radar was mounted on. The objective of the GPR tests is to determine areas of the bridge deck with potential corrosion or delamination (cracks) at the top layer of steel reinforcement.

Figure 3 - GPR testing with the 2GHz air horn antenna on I-25 in Douglas Wyoming.

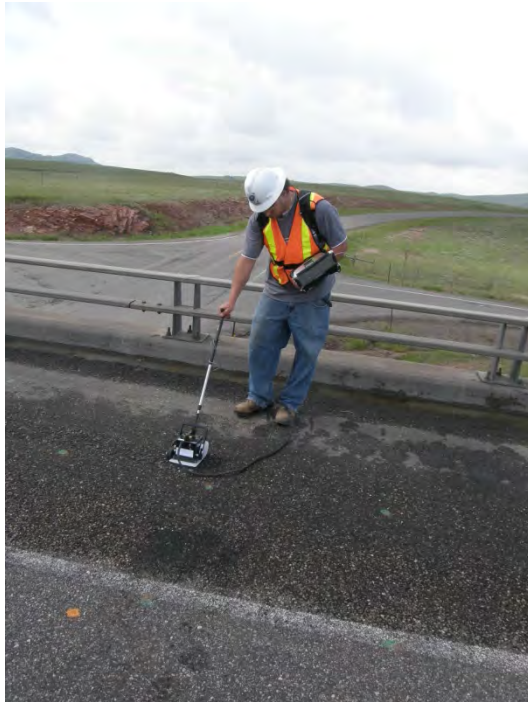
Figure 2 - Ingegneria Dei Sistemi (IDS) Aladdin acquisition system with a full-polar 2000 MHz antenna and Panasonic Toughbook CF-19.

Field GPR Test Program. Ground Penetrating Radar (GPR) tests were conducted using an Ingegneria Dei Sistemi (IDS) Aladdin acquisition system with a full-polar (bi-polar) 2000 MHz antenna and a Geophysical Survey Systems, Inc., mono-polar 1600 MHz antenna. The tests were performed from the top side of the deck. The objective of the GPR testing was to locate possible areas of delamination within the bridge deck due to possible corrosion of the top layer of the rebar mat. The tests with the 1600 MHz antenna were conducted using a grid spacing of 1 foot along the E-W direction and 0.25 inches along the N-S direction (along each scan line). The tests with the Ingegneria Dei Sistemi (IDS) Aladdin acquisition system were conducted using a grid spacing of 4 inches along the E-W direction and 0.20 inches along the N-S direction.

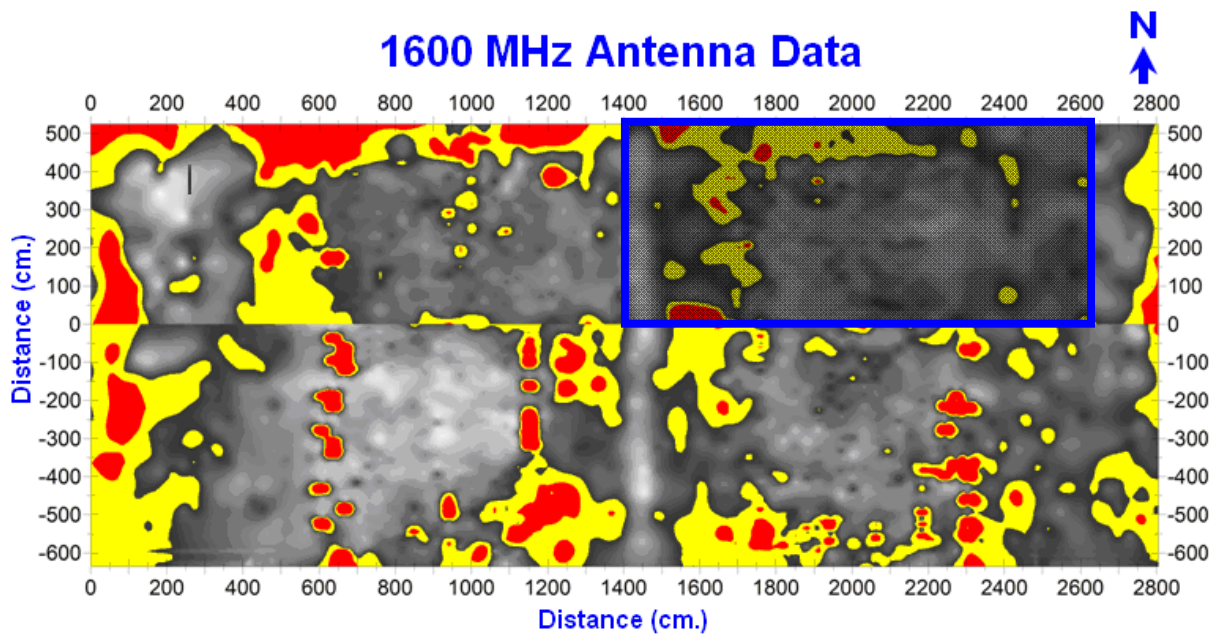
Figure 6 – 1600 MHz antenna data for delamination (red) and corrosion (yellow) results. Notice the darkened region highlighted in blue. This is where IDS’s full-polar 2000 MHz Aladdin antenna and the 1600 MHz antenna are directly compared.
