FHWA-WY-15/01F

## INVESTIGATION OF APPROACH SLAB AND ITS SETTLEMENT FOR ROADS AND BRIDGES

Department of Civil & Architectural Engineering  
University of Wyoming  
1000 E. University Avenue, Dept. 3295  
Laramie, Wyoming 82071

December 2014

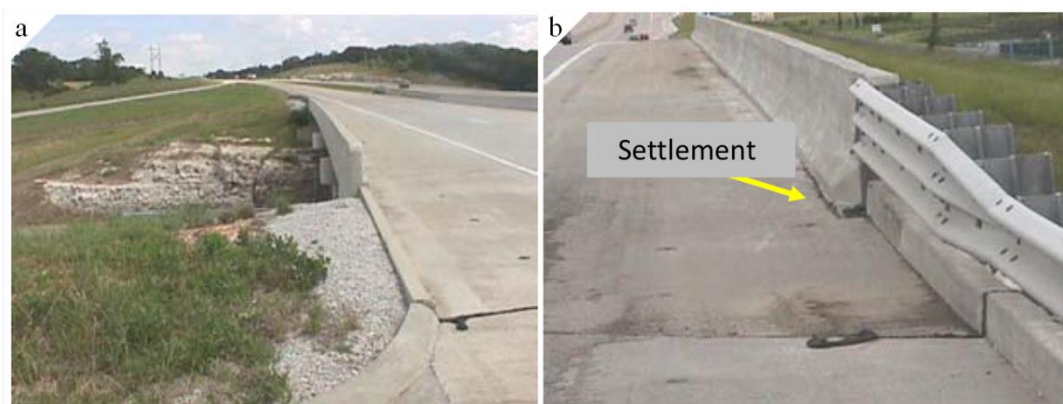
**Figure 2(a) No settlement on bridge approach slab with unused mudjack holes shown, and (b) Differential settlement occurred on a bridge approach slab (Petry et al., 2002)**

was observed. On the other hand, thick embankment fill with no drainage led to settlement (figure 2).

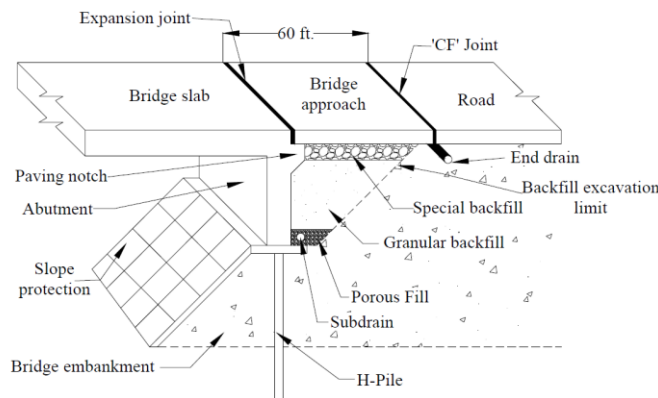
**Figure 9 Schematic diagram of Iowa DOT bridge approach section (White et al., 2005)**

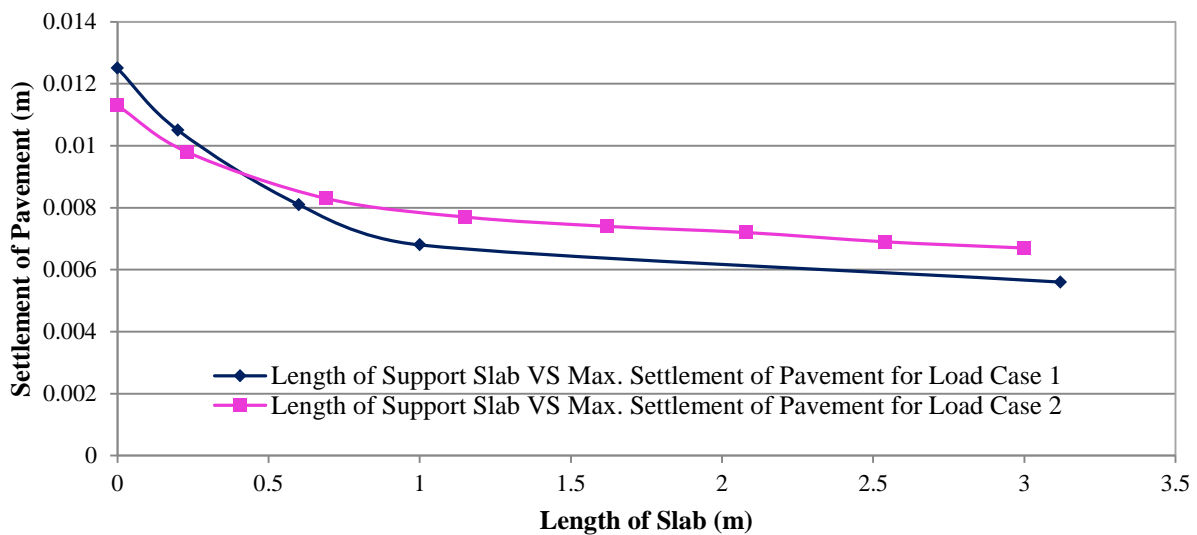
**Figure 14 Settlement as a function of the length of slab (Ha et al. 2002)**

Length of Support Slab (m)	Max. Settlement (m) of the Pavement	Length of Sleeper Slab (m)	Max. Settlement (m) of the Pavement
0.00	0.0125	0.00	0.0113
0.20	0.0105	0.23	0.0098
0.60	0.0081	0.69	0.0083
1.00	0.0068	1.15	0.0077
3.12	0.0056	1.62	0.0074
-	-	2.08	0.0072
-	-	2.54	0.0069
-	-	3.00	0.0067

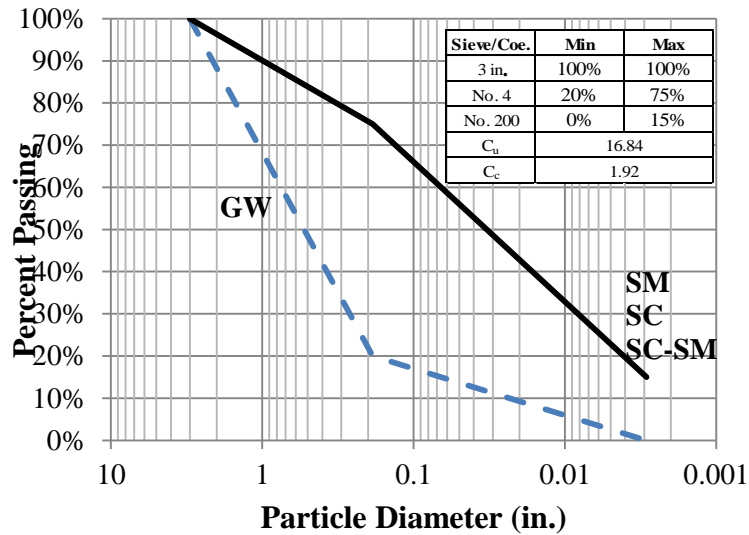
**Figure 55 Gradation of well-graded backfill material in Hawaii**

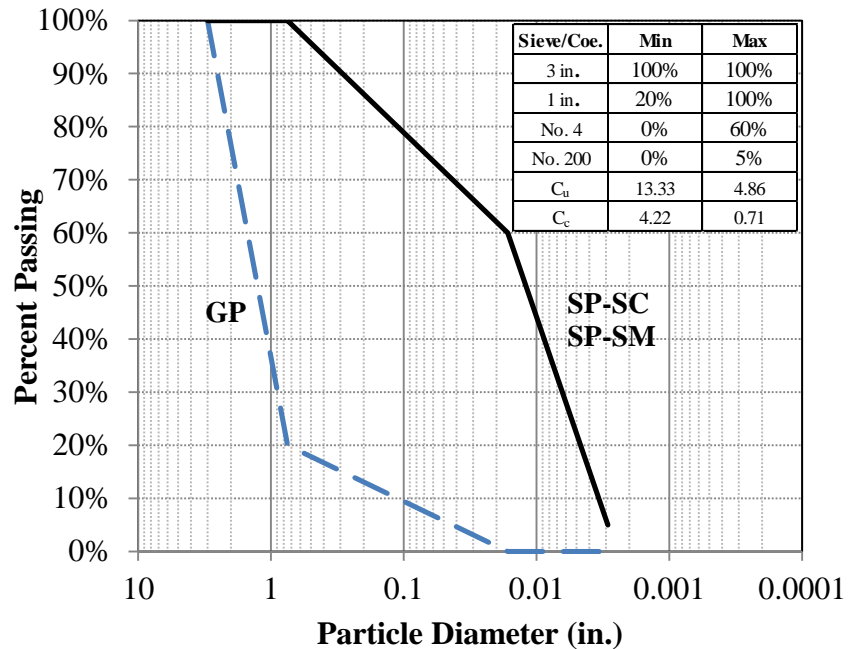
**Figure 63 Poorly-graded backfill material gradation in Colorado (FPG)**
