Hams Fork Road

Jennifer Hoffman, P.E.
Kemmerer Resident Engineer

Purpose of this meeting

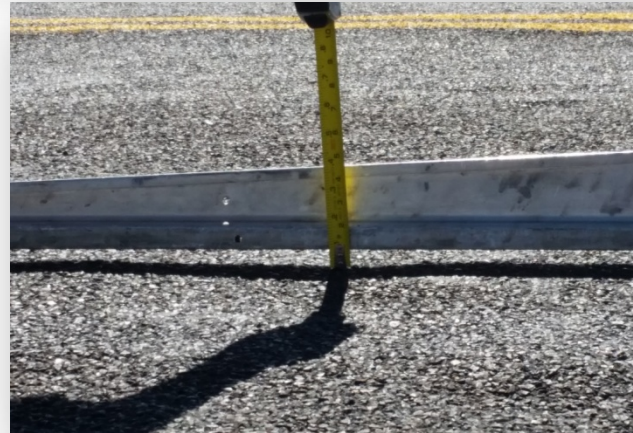
WYDOT has identified areas that do not meet ride specifications

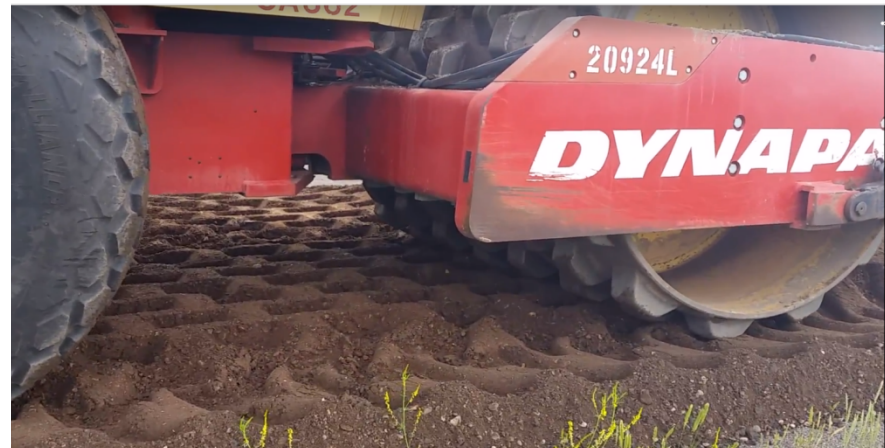
- ▶ The contract requires specific compaction efforts for the FDR.
 - Roller pattern is established using a nuclear density gauge within a short test section of the roadway.
 - Roller effectiveness is continually monitored by the nuke gauge daily throughout the project.
 - “Break Over” specification used rather than a maximum density specification.

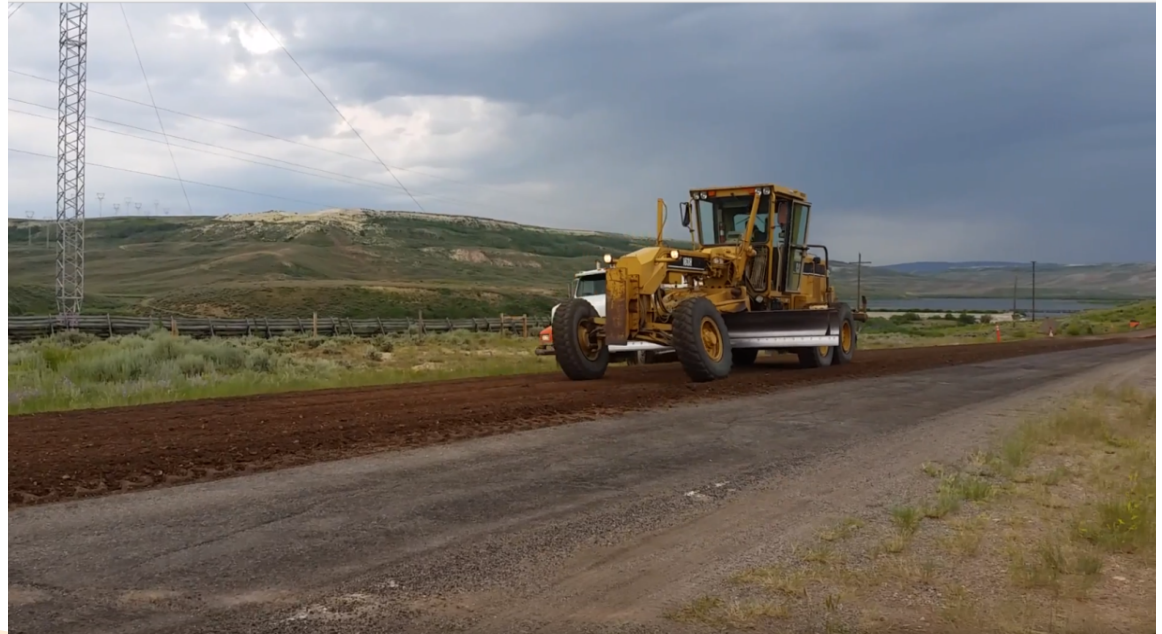
Was the roughness in the road caused by poor grading operations?

- ▶ A motor grader made several passes through the FDR material during the compaction process.
- ▶ The specification depicted on previous maps applies to the grade of the road.
